# PHENIX WEEKLY PLANNING

10/13/2011  
Don Lynch

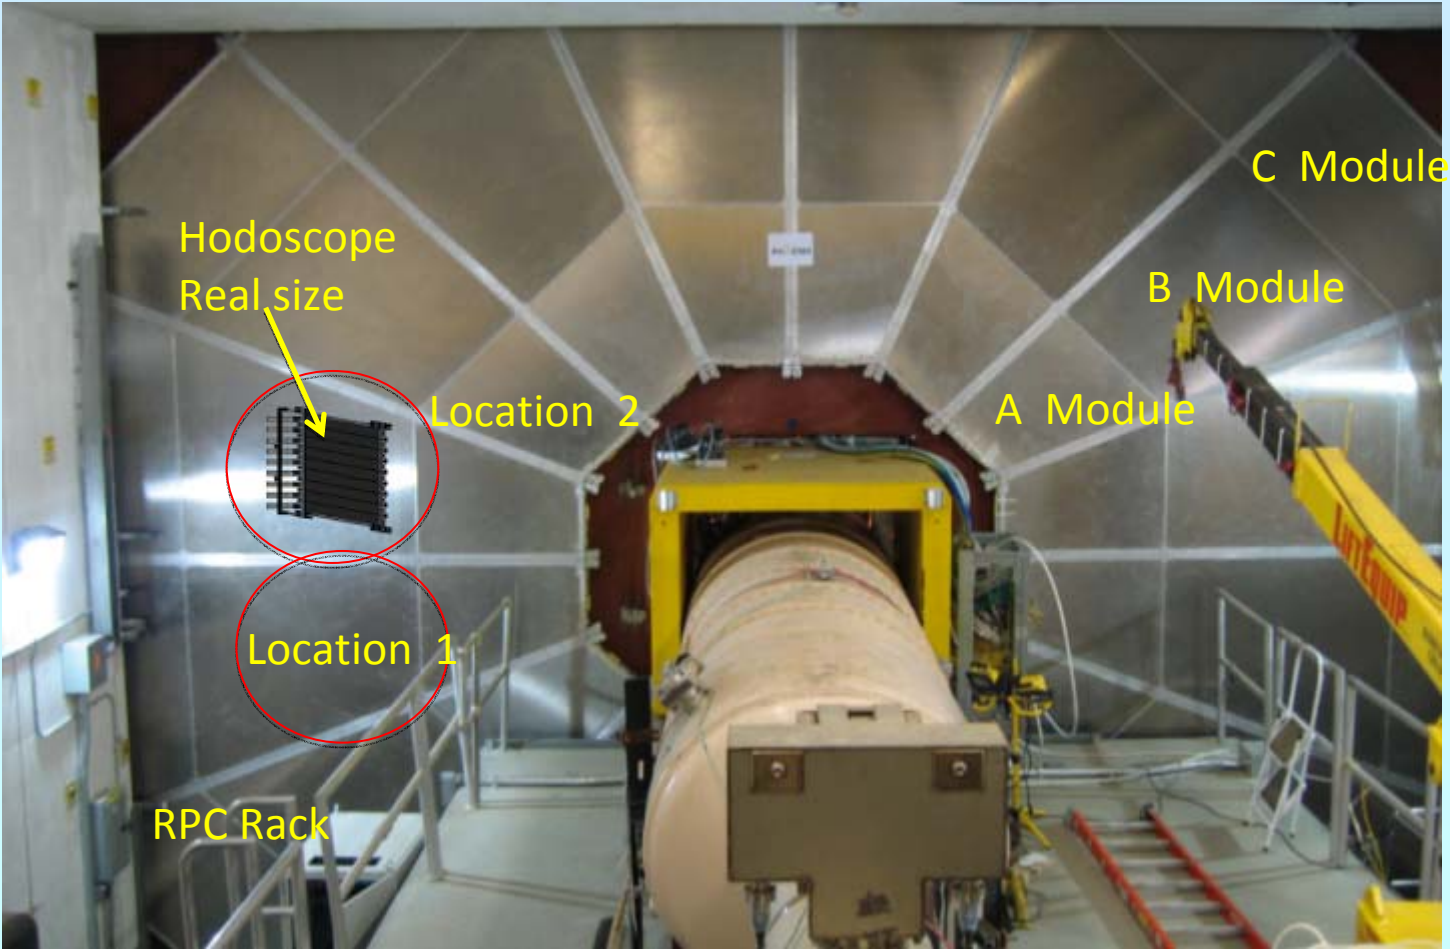
# RPC Hodoscope

Close to RPC3 electronics rack  
Less Beam background region

Location 1 or 2 would be good position

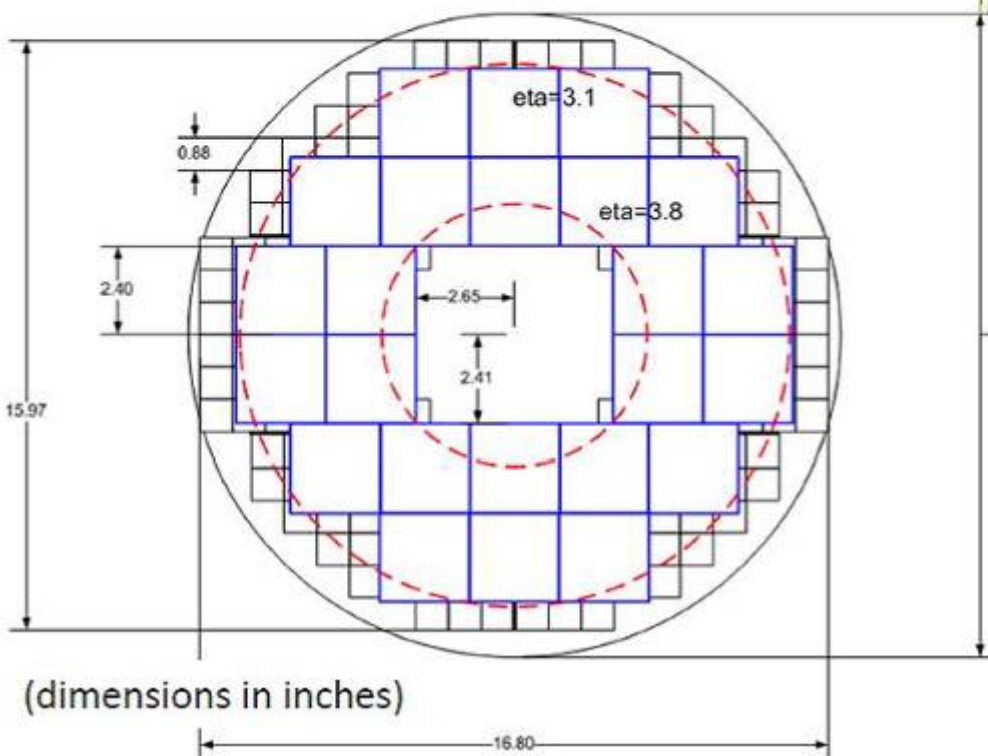
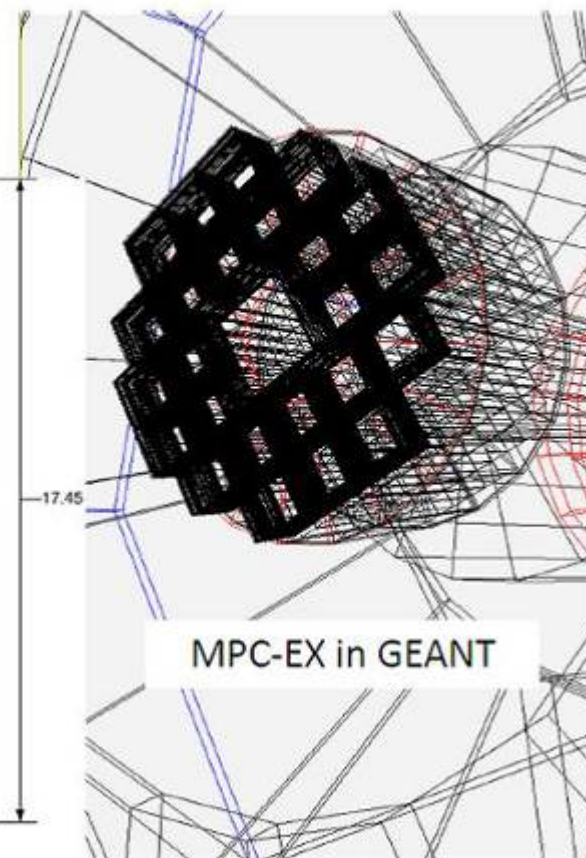
# Design of the MPC-EX

Detector is designed around 6.2cm x 6.2cm modules (Si pad or strip detectors) separated by 2mm tungsten plates.
